A Survey of Building and Content
Damage Resulting from Hurricane
Andrew in Nine Industrial Properties

Norris Stubbs¹, Eng.Sc.D., P.E., and Dale Perry², Ph.D.

March 8, 1993

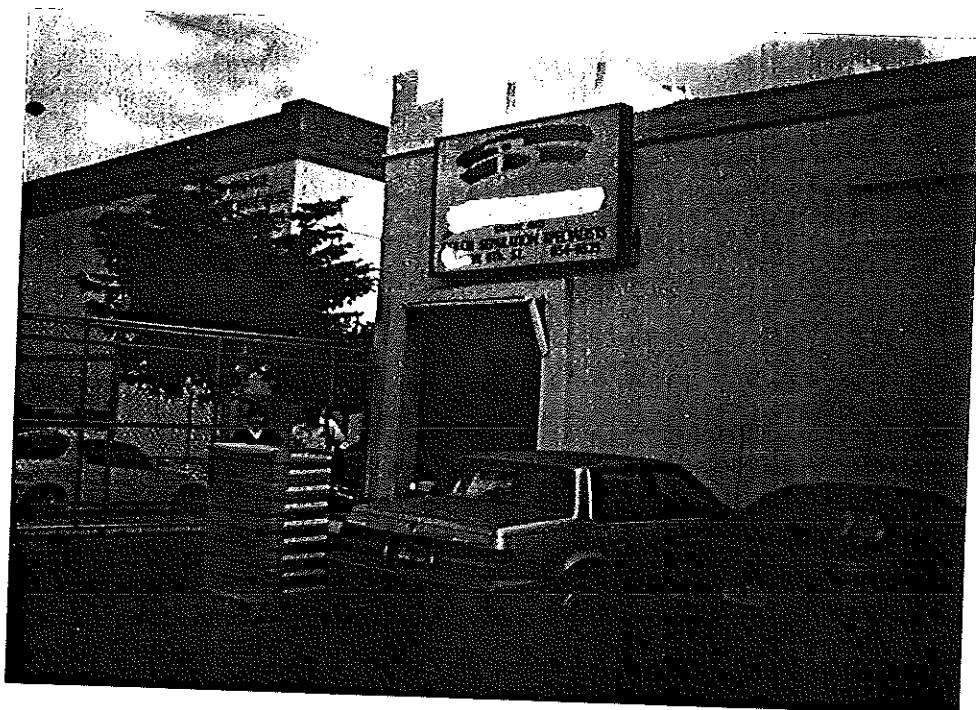
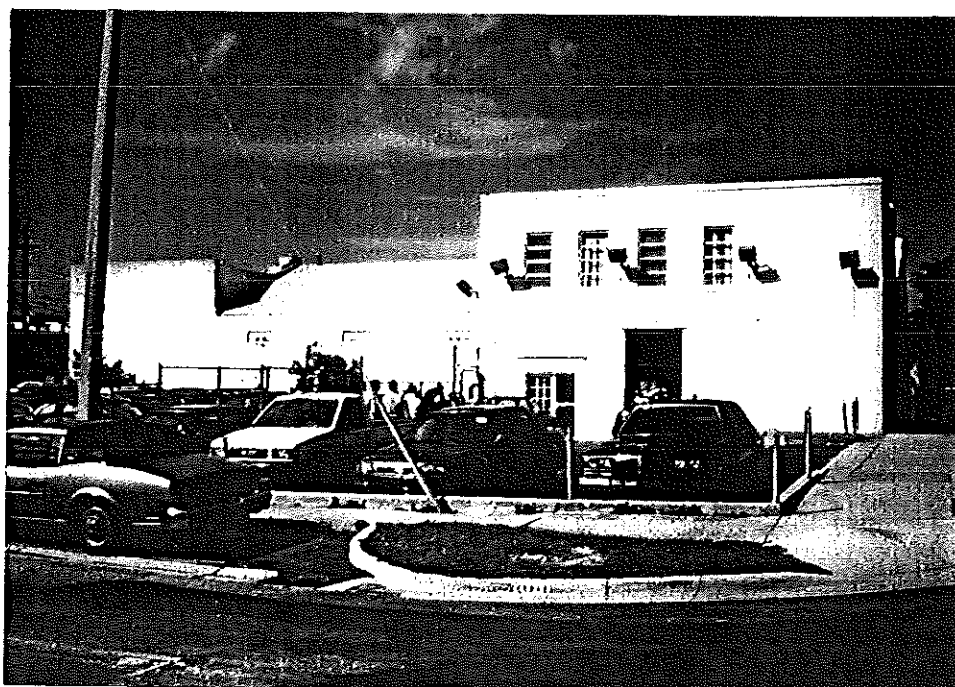
Figure 4: View of Building 1

Openings: Part A: 1 window failed (missiles)

Openings: 2 windows failed (missiles)

Roofing: Improper design, installation, or maintenance of roofing

Water penetration via windows on south & north faces caused damage to printing stock; intake of water into exhaust vent of scanner (saline content corroded critical parts; see Figure 13)

1. Isolate sensitive equipment from outside environment
2. Provide secondary mitigation for contents

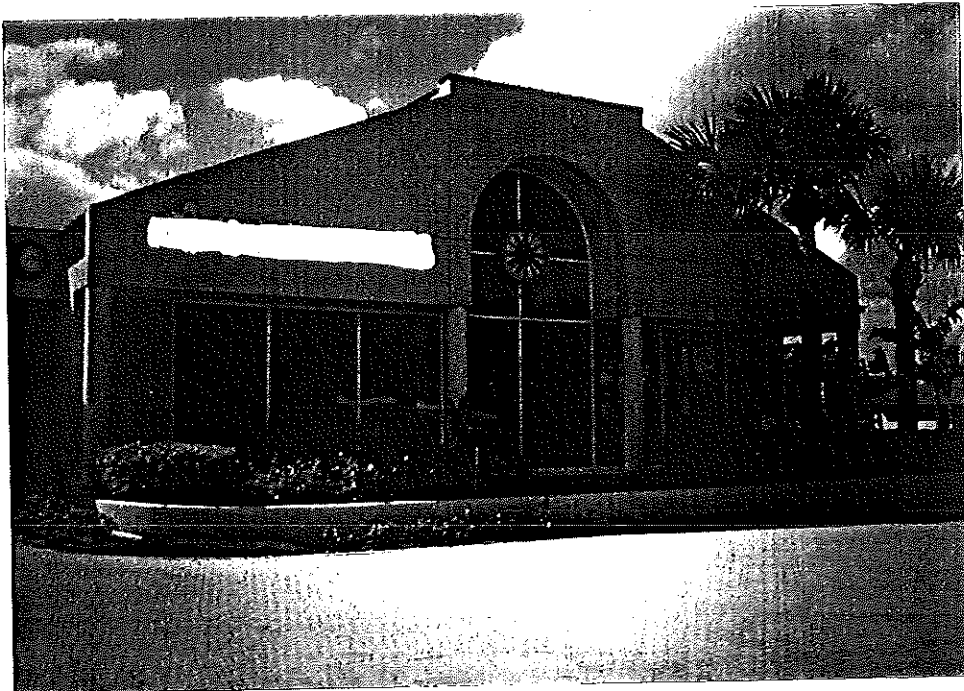
Figure 6: View of Building 3

Roof: None
 Roofing: Minor damage to skylight

Provide secondary mitigation to furniture

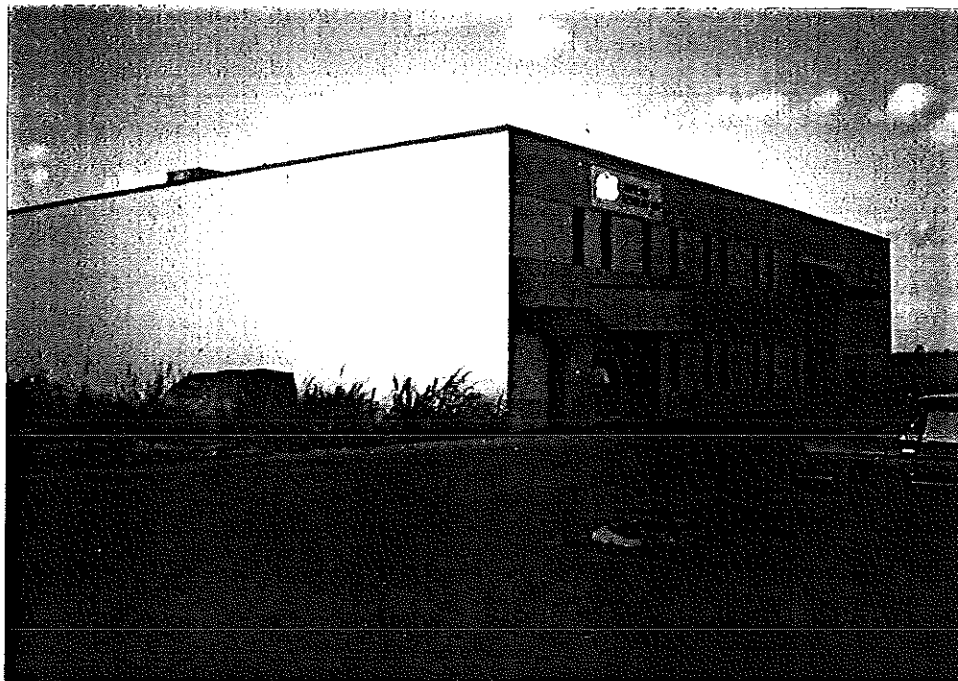
Figure 7: View of Building 4

Roofing: 1 lost A/C unit; damage to heat exchanger coils; flashing damage

Roofing: Improper installation or maintenance of roof flashing

Air conditioning units: Missile impact from gravel ballast

- (1) Eliminate gravel ballast hazard on roof
- (2) Provide periodic inspection and maintenance of roofing

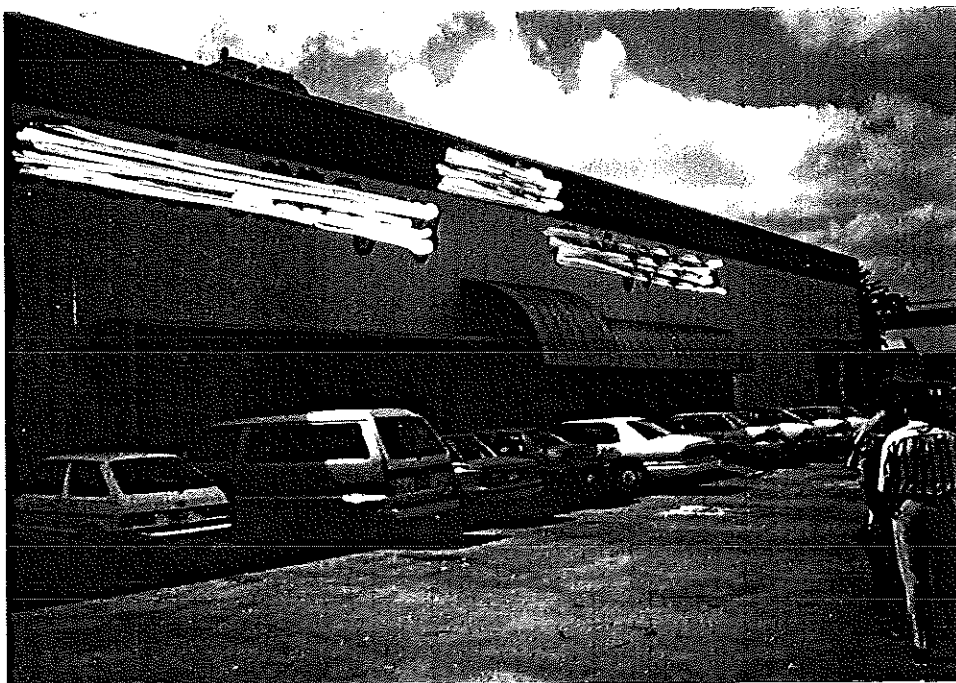
Figure 8: View of Building 5

Roofing: 100% damage; A/C units, vents 100% damage

Minimal damage to one weaving machine

Roofing: Improper design, installation, or maintenance of roofing

Glass window damage: Missile impact

Provide secondary protection for contents

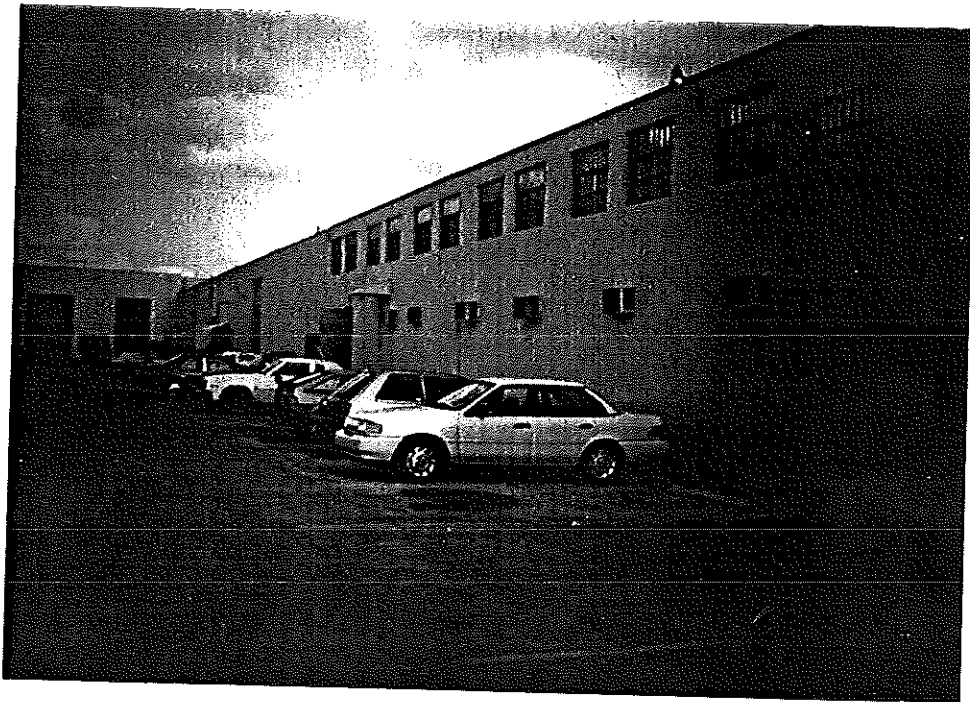
Figure 9: View of Building 6; Part A

Roofing: Total
Openings: 10% glass damage

Water damage to machines, lathes, milling machines

Roof: Improper design, assembly, or maintenance or roofing
Openings: Missile impact to glass windows

Provide secondary mitigation scheme for contents.

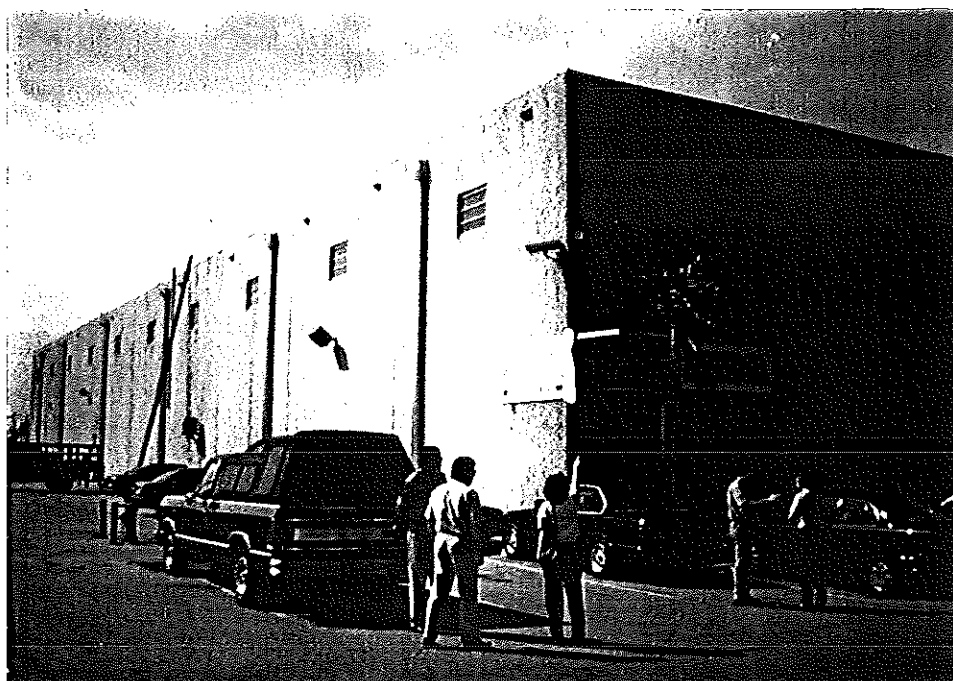
Figure 10: View of Building 7

Roofing: Damage to roof flashing; Roof leakage noted previously (prior to hurricane), and often; 2 A/C units damaged
Openings: Damage to 30% glass windows on East face

A/C and flashing damage caused by wind

Water penetration from broken windows and roof

Provide secondary mitigation scheme for contents

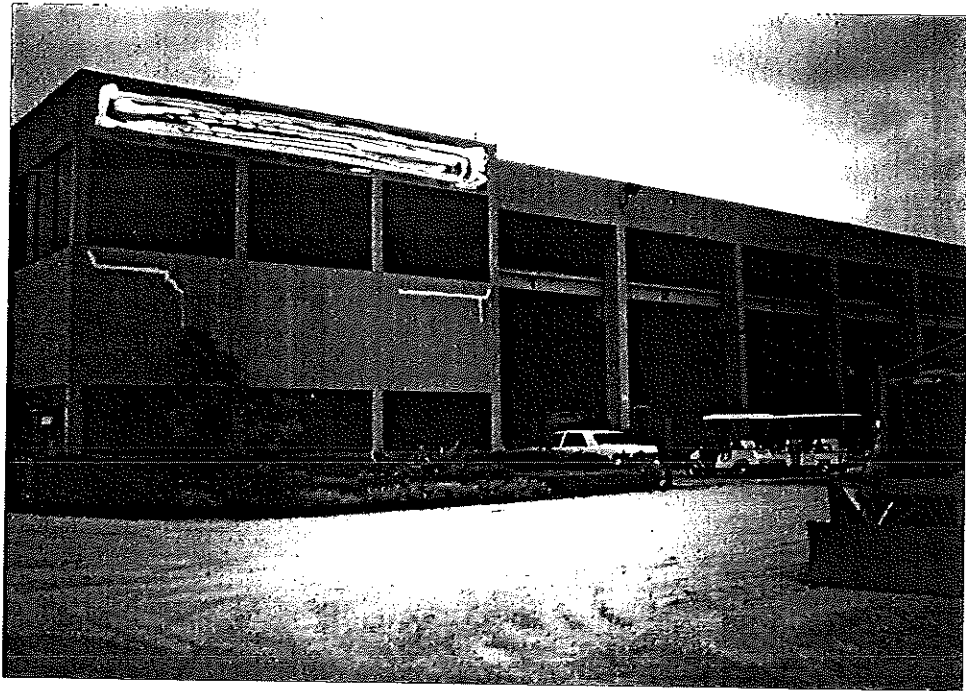
Figure 11: View of Building 8

A/C: 6 damaged units

Roofing: Improper design, installation, or maintenance of roof

- (1) Provide periodic inspection and maintenance of roofing
- (2) Ensure that A/C units are properly anchored
- (3) Eliminate obstruction of roof drainage part by skylight

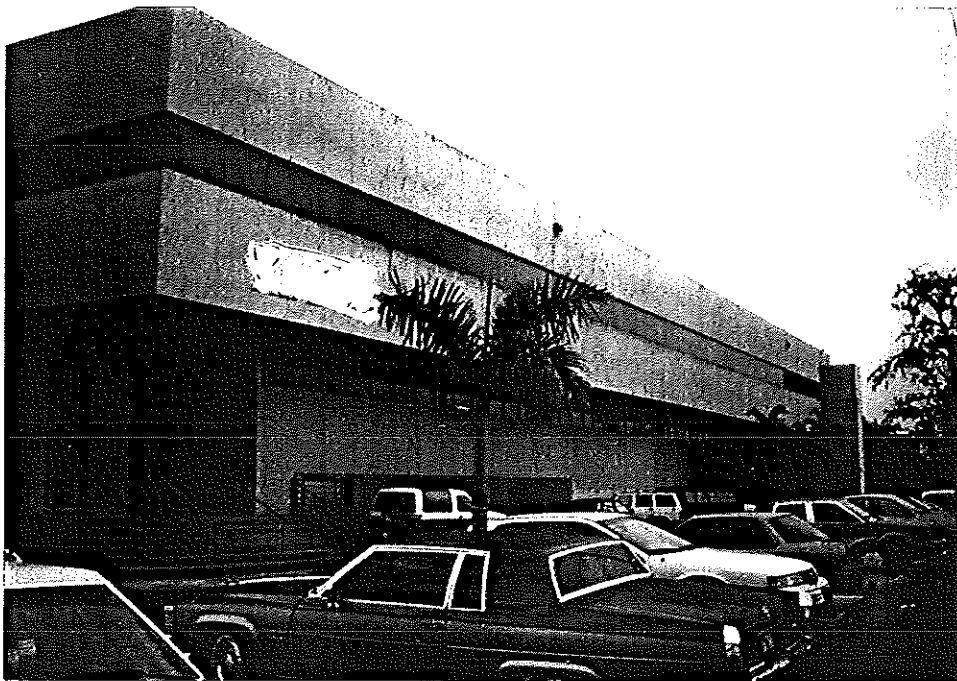
Figure 12: View of Building 9

Roofing: Improper design, installation, or maintenance of roof

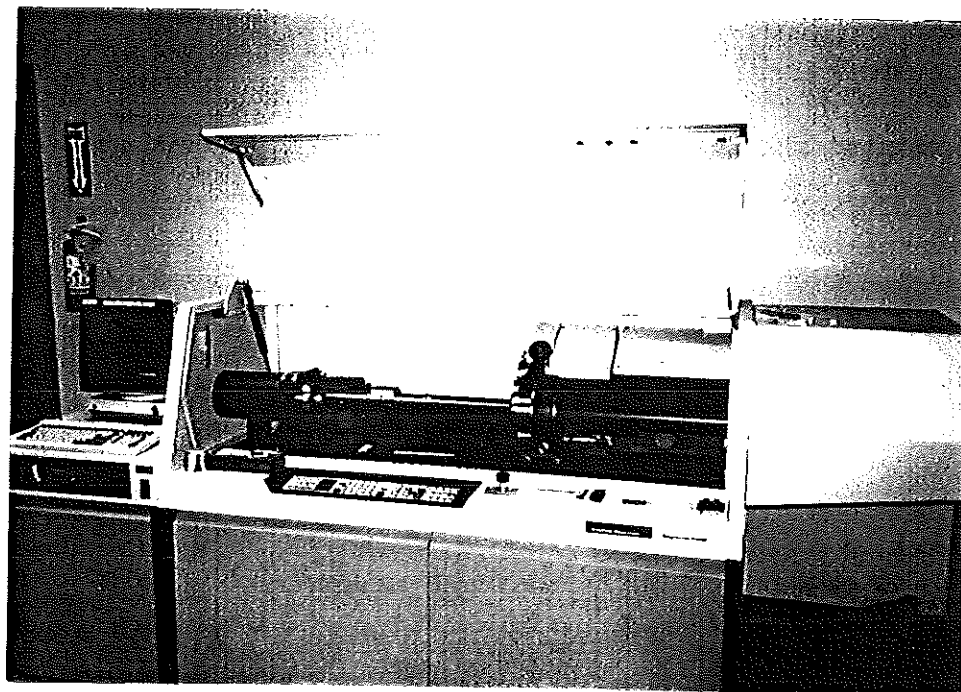
The single unexpected finding in this survey was the realization of the damage path to the Color Separation Scanner at . The machine is located on the second floor of Part B of the structure (See Table 1) and is positioned against the south wall of the building. An intake vent from the exterior of the south wall is connected directly to the machine. During the hurricane, water entered the vent and the moisture found its way to the interior of the machine. The salt water reacted chemically with the machine parts to effectively corrode the internal parts. This path of damage is quite different from the more obvious water contact via a leaking roof or a broken window.

Figure 13: Color Separation Scanner at
Lower Picture Identifies Intake Vent

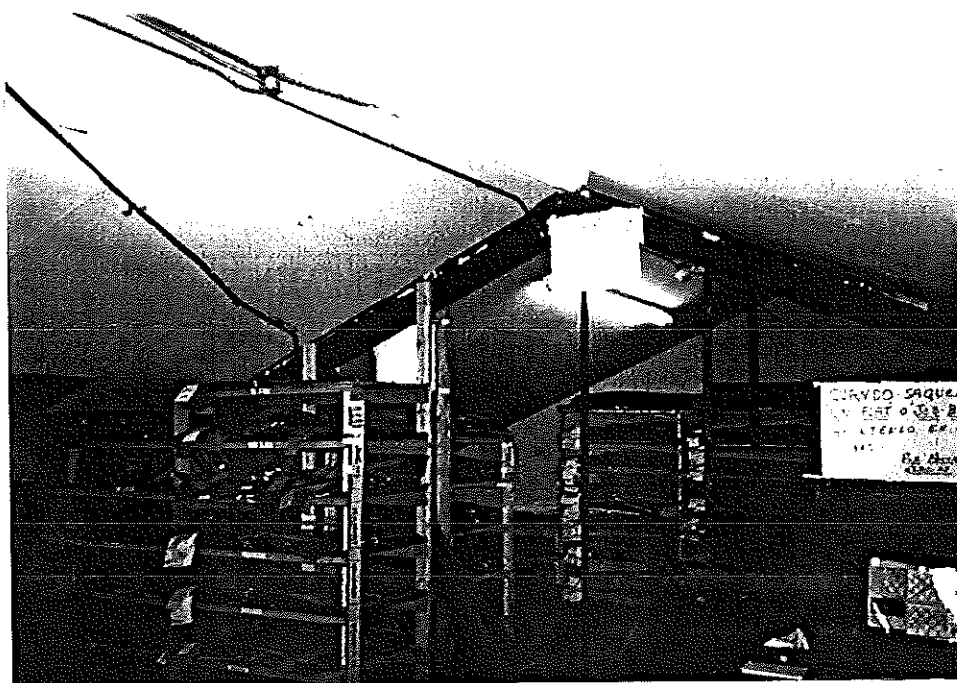
Figure 14. Example of valuable contents with no second line of defense against water contact.
